## **Dolgarrog Powerstation, Wales Modernisation**

# **CaseStudy**

## **CASE STUDY** Dolgarrog Modernisation

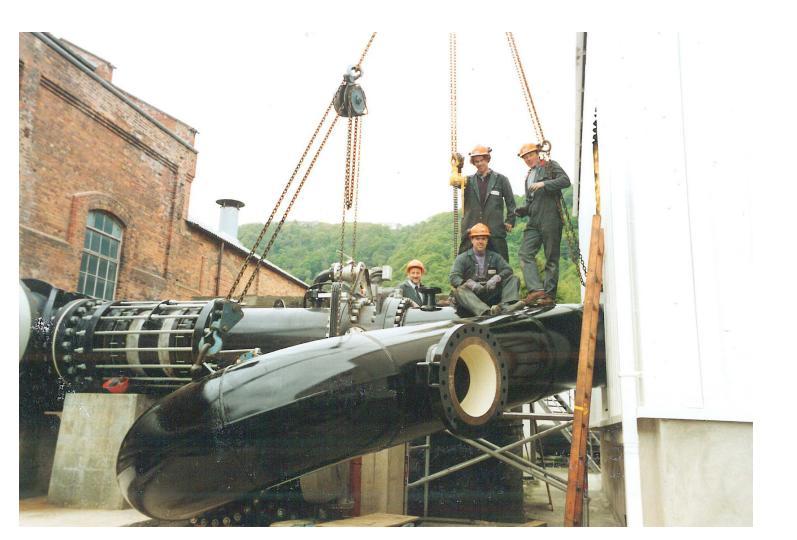
Original pipework being fitted by Gilkes engineers in 1994

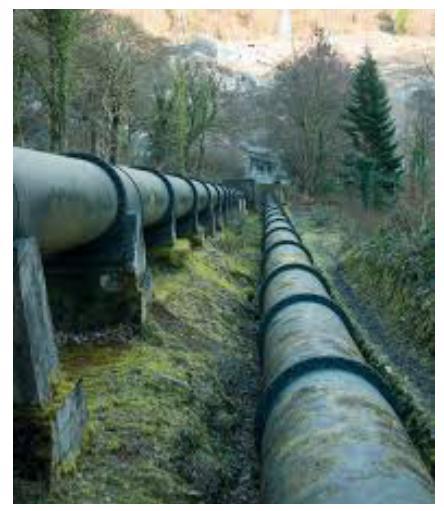
Penstocks for both schemes

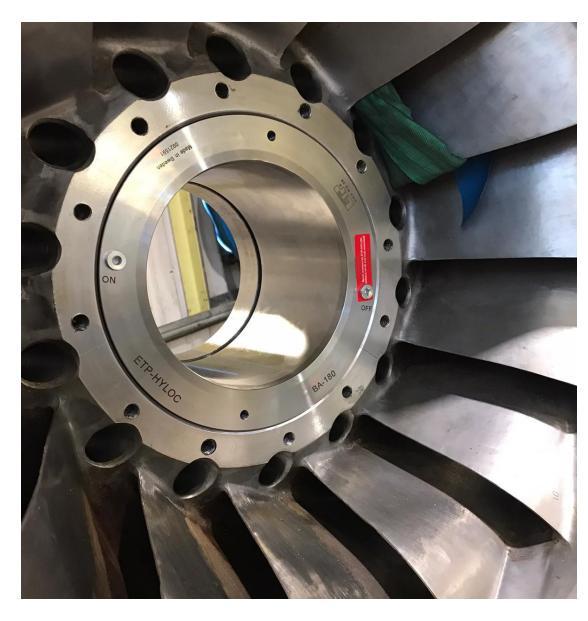
New hydraulic locking bush

The initial phase of the refurbishment in 2019 met with some challenges. As with any mechanical refurbishment, the extent of the work can be somewhat unknown until the machine is fully stripped down and inspected. On this occasion, the hydraulic locking bush for the runner would not release due to age. It was decided to continue with the rest of the work scope and revisit the runner refurbishment at a later date.

In 2020, our engineering team returned to site during the planned 2020 outage. With a replacement locking bush, they were able to remove the runner and fully complete the runner and top chamber refurbishment.

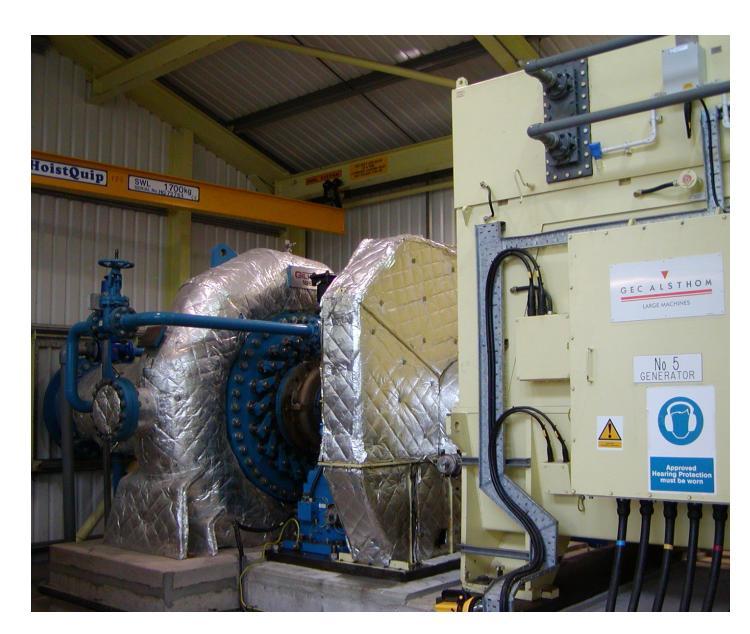
**5MW Francis Turbine**

The 5MW turbine on the low head Llyn Coedty scheme is a Gilkes horizontal Francis turbine coupled to a six pole synchronous generator. The scheme, along with the associated penstock pipework, inlet valves, and auxiliaries, was designed and installed by Gilkes in 1994.
